Silicate Masonry Paint weathers Orkney storms

Products - Silicate Masonry Paint

Project - Seafront home, Orkney

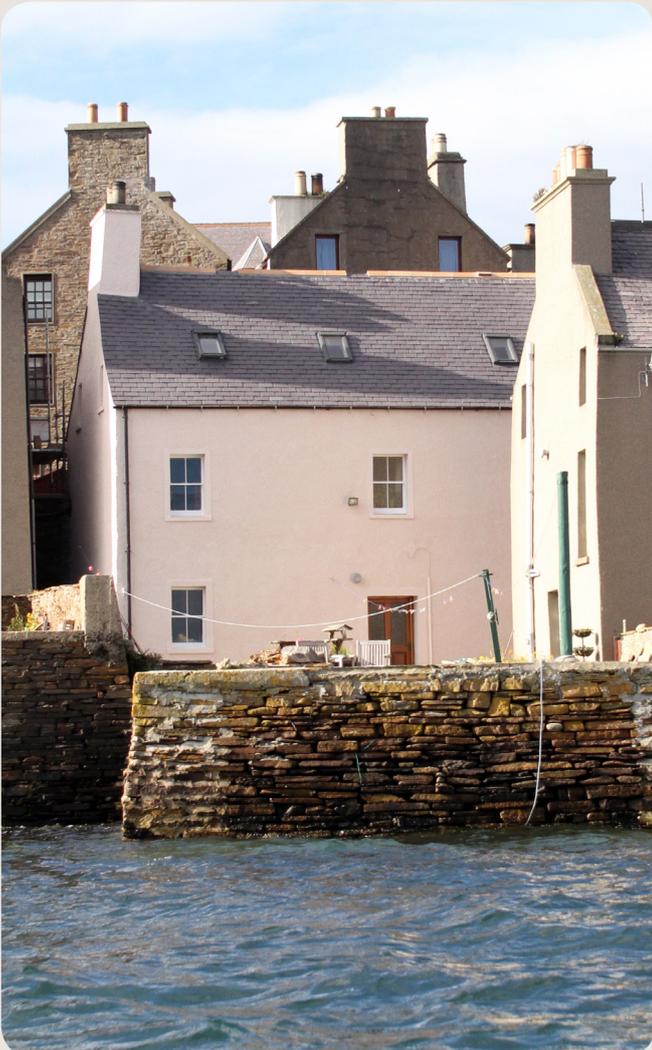
Front page - A bespoke shade, Setting Plaster, was selected to match the town's conservation colour palette.

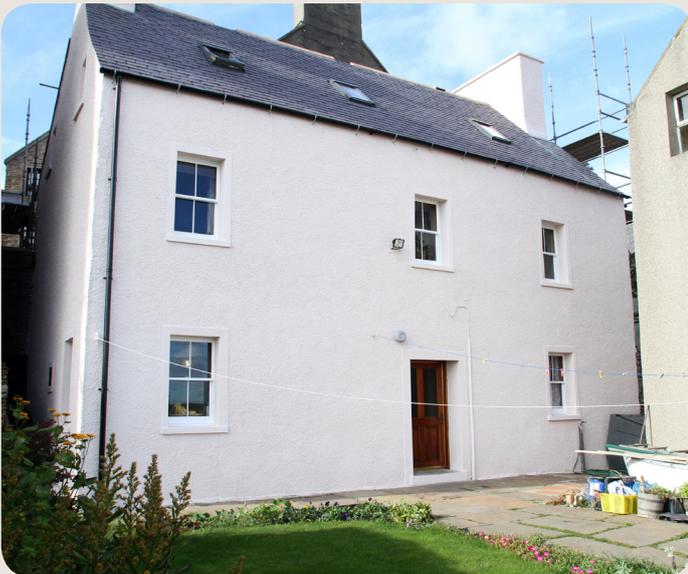
This page (top left) - Ecopro Silicate Masonry Paint was applied to the harling coated walls and chimney stacks as well as the smooth cement facings around doors and windows.

Billy added: "My walls are coated with harling, the traditional Scottish render incorporating aggregate. First, the walls were thoroughly cleaned, using two applications of a fungal wash to remove lichen and any earlier, residual paintwork.

"Then the silicate primer was applied, followed by two coats of silicate paint, the first thinned with 20% primer. The products have a lot of body, which helped fill any cracks in the harling. A roller was fine for most of the job. A brush was only needed around the edges and where the aggregate was particularly large.
